## Community-Based Assistance in Planning and Rehabilitation of Early Childhood Education Facilities at TK ABA 25 Summersari, Malang

<sup>1</sup>Bachelor of Civil Engineering, Universitas Muhammadiyah Malang

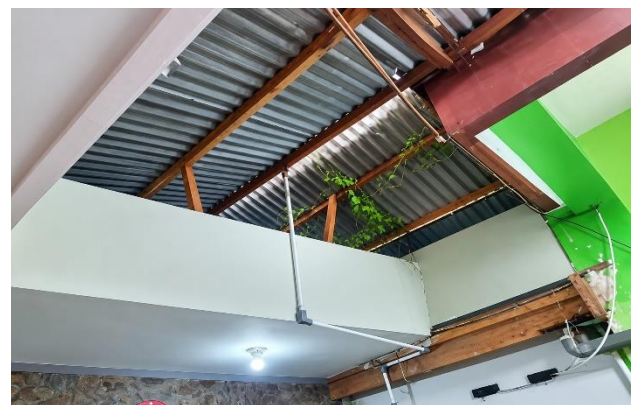
Figure 1. The roof between classrooms at TK ABA 25 is damaged, causing flooding when it rains.

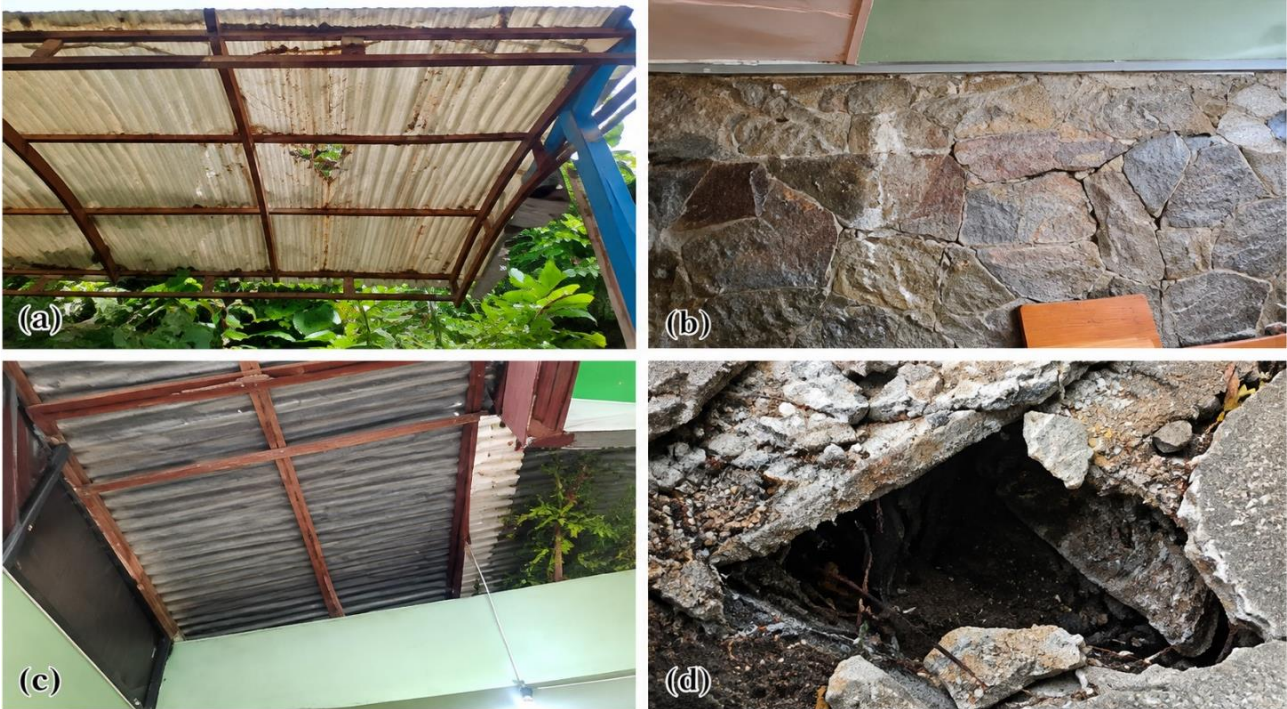
| Aspects Evaluated | Conditions prior to the assistance program | Conditions following the assistance |
|---|---|---|
| Roof | Leaks have occurred in several sections of the roof, causing water to enter the classrooms (Figure 2a, 2c.) | The areas requiring repair have been identified and measured at approximately 33 m <sup>2</sup> and are a priority for rehabilitation |
| Partition wall | Cracks were found that could potentially spread and pose a risk to users (Figure 2b) | The extent of the damage has been documented and included in the remediation plan |
| School Road Access | The surface of the access road is damaged and potholed (Figure 2d) | The damage has been identified and included as part of the rehabilitation plan |

Figure 2. (a) The polycarbonate roof has holes and is leaking; (b) The school fence wall is cracked; (c) The roof over the walkway has holes and leaks; (d) The school access road is full of potholes and severely damaged

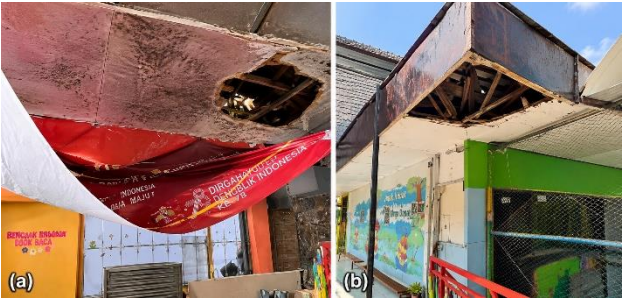
| Aspects Evaluated | Conditions prior to the assistance program | Conditions following the assistance |
|---|---|---|
| Ceiling | Some sections of the ceiling have been damaged due to a roof leak (Figure 3) | The damaged sections have been identified, and repairs are being carried out in stages according to priority |

Figure 3. (a) The damaged ceiling at TK ABA25, covered with a banner due to a leaky roof; (b) Inspection and repair of sporadically damaged ceilings
