## Community-Based Assistance in Planning and Rehabilitation of Early Childhood Education Facilities at TK ABA 25 Summersari, Malang

<sup>1</sup>Bachelor of Civil Engineering, Universitas Muhammadiyah Malang

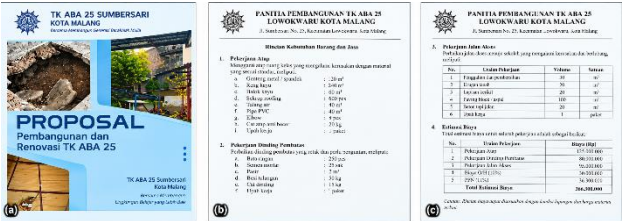
Figure 4. (a) Cover page for the proposal for the construction and renovation; (b) Details of the materials needed for the renovation; (c) Budget plan for the renovation.

| Aspects Evaluated | Conditions prior to the assistance program | Conditions following the assistance |
|---|---|---|
| Cost planning | BoQ and budget plan not yet available to serve as a basis for rehabilitation | BoQ and budget plan compiled based on measurement results and work requirements (Figure 4) |
